Navajo Abandoned Uranium Mine

Site Screen Report

Tommy James Mine AUM Site

Navajo AUM Northern Region

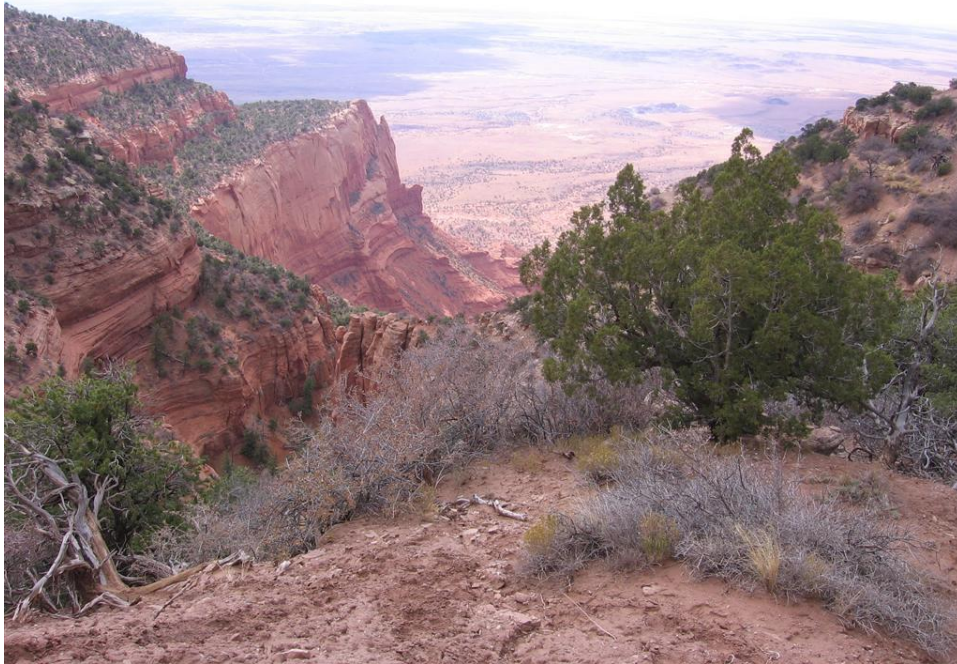
Photo 1. Direction down towards the site

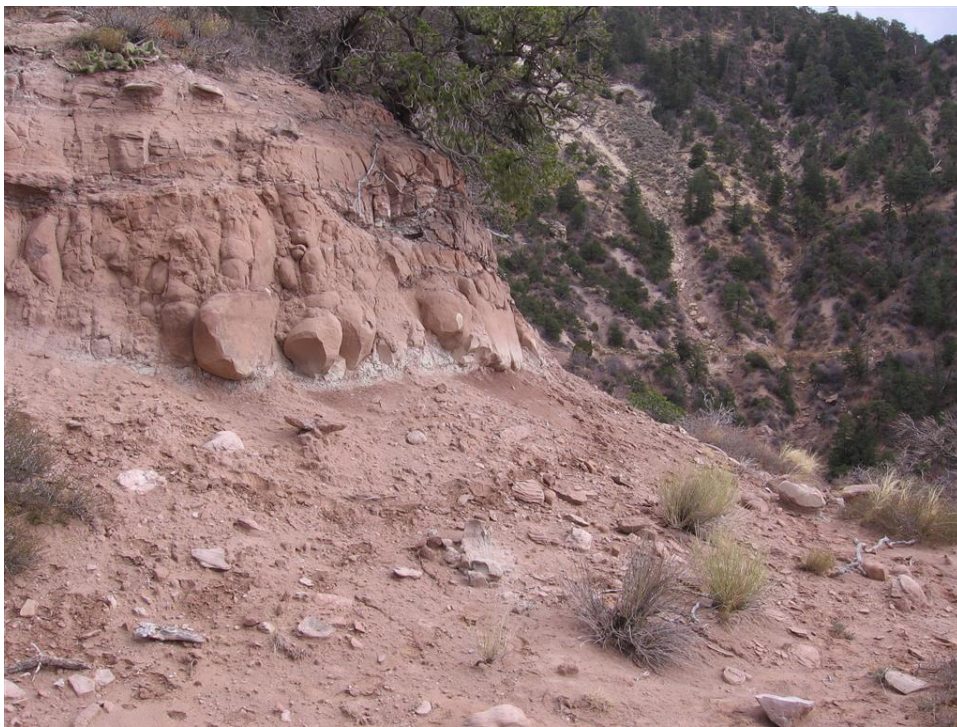
Photo 2. Washed out path leading to the site

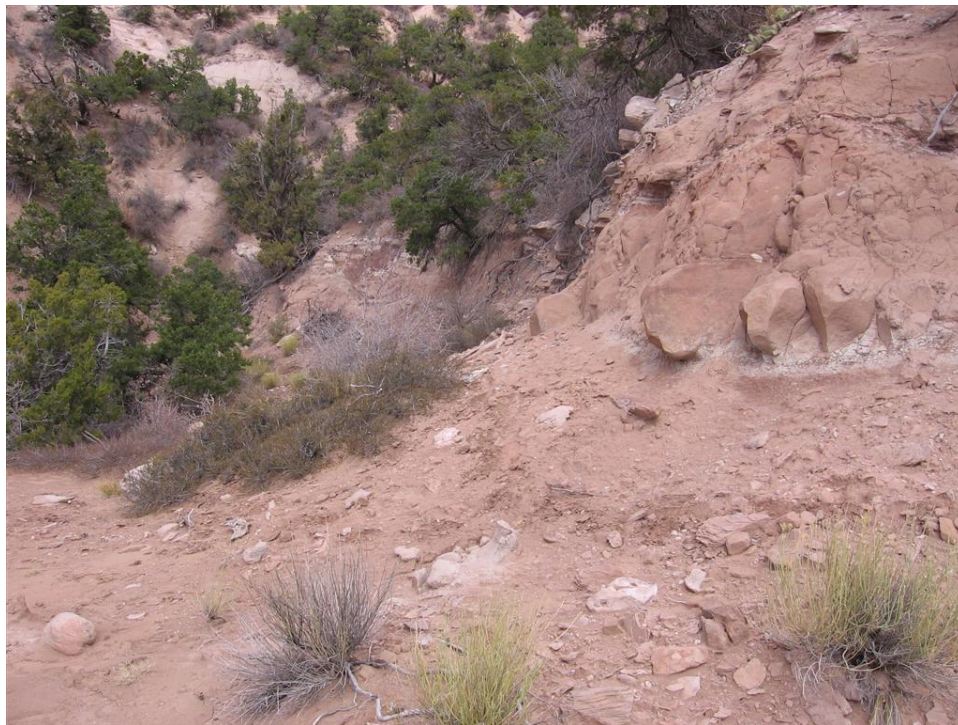
Photo 3. Washed out path leading towards the site
